Manhole Inspection Summary

Manhole # S06YY1007MH

Insp Date: **6/20/06 1:18 PM**

Location Address: **3910 CLARKS LN**

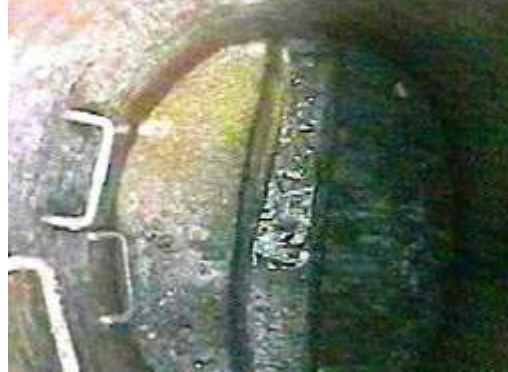
Top View

Evidence of surcharge - Bench debris.
Corroded steps.

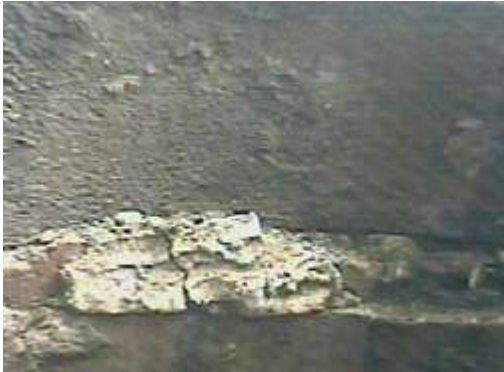
Defect

Frame leaks. Corbel infiltration.

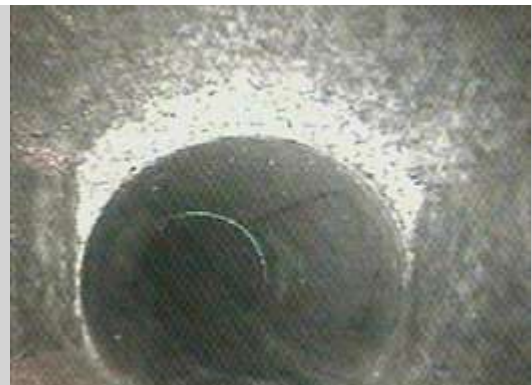
Pipe Out @ 12 O'Clock

Invert Depth: **8.19** (ft.) Flow Characteristics: **Slow**

Infiltration: **None** Pipe Seal Cond: **Unknown**

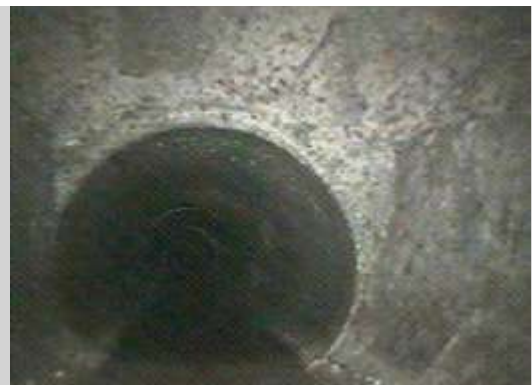
Pipe In @ 6 O'Clock

Invert Depth: **8.15** (ft.) Flow Characteristics: **Slow**

Infiltration: **None** Pipe Seal Cond: **Unknown**
